Manhole Inspection Summary

Manhole # S21KK1004MH

Insp Date: **11/20/06 9:49 AM**

Location Address: **4426 CLYDESDALE AVE** Cross Street: **BUENA VISTA AVE**

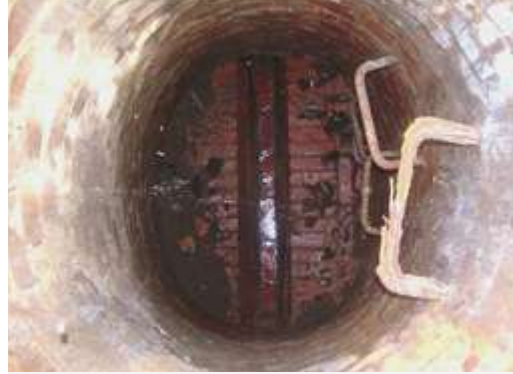
Top View

Adjustment, Corbel and Barrel infiltration.
Corroded steps. Evidence of surcharge -
Bench debris.

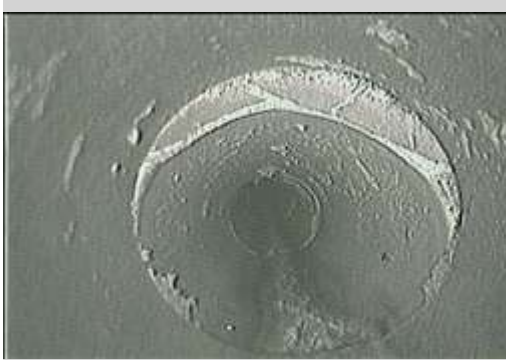
Inside the I6

Offset joint

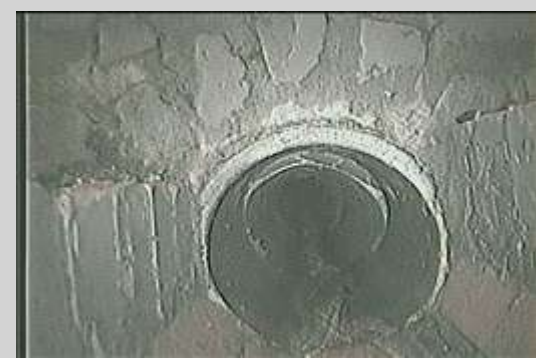
8 in. Circular Gravity Sewer Pipe Out @ 12 O'Clock

Pipe Material: **Clay** ☐ Pipe Lined

Invert Depth: **8.73** (ft.) Flow Characteristics: **Slow**

Infiltration: **None** Pipe Seal Cond: **Unknown**

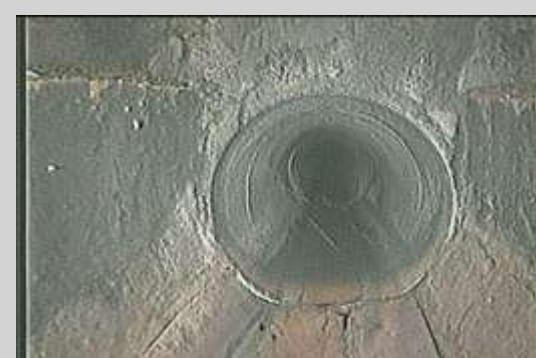
8 in. Circular Gravity Sewer Pipe In @ 6 O'Clock

Channel cracks.

Infiltration: **None** Pipe Seal Cond: **Cracked**
